## Pix Piece #04 July 2024

## Pix Brook Water Quality: Nickel

Sampling for Nickel in the Pix Brook, where does it come from and why is it important?

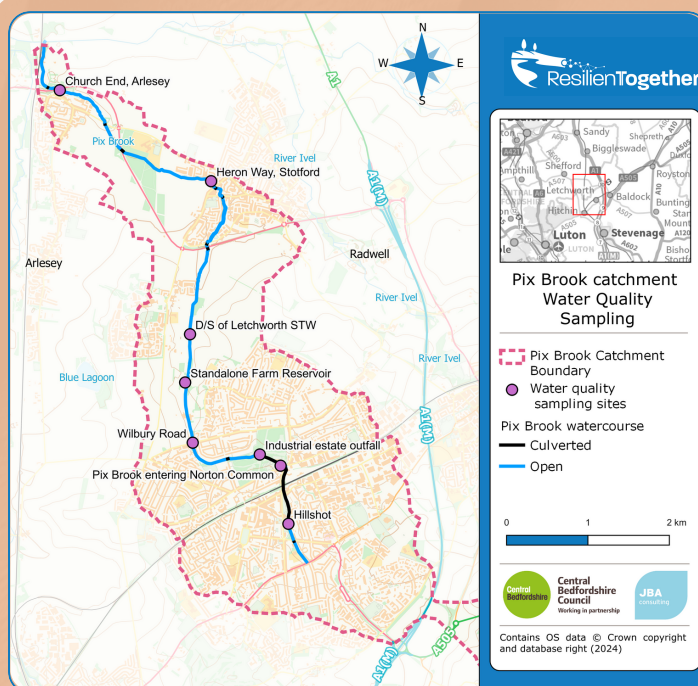
Figure 3. Map of Pix Brook water sampling locations

ResilienTogether undertook water quality sampling for a nine month period at eight sites along the Pix Brook, shown in Figure 3 (Right). Pix Piece #01 provides information on how we undertook our water quality sampling. This provided a baseline water quality for a range of determinants across a long stretch of the watercourse, which allowed us to build up a picture of where different determinants may be an issue and why. This Pix Piece focuses on the Nickel levels in the Pix Brook, what they mean and why they are important.

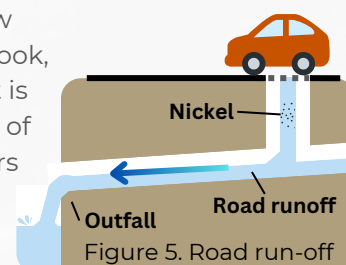
Figure 4. Nickel levels across the Pix Brook compared against Water Framework Directive acceptable levels

Figure 4 shows that the average nickel levels in the Pix Brook fall within the acceptable water quality threshold. There is an increase in concentrations between Norton Common inlet and Wilbury Road that may be linked with an increase in highway runoff entering the Pix. Sites downstream of the waste water recycling centre (STW) have higher nickel levels than upstream sites. This indicates the waste water entering the Pix Brook is contributing nickel and/or nickel from highway runoff is accumulating. Due to it's low concentrations in the Pix Brook, nickel is not a concern but it is an indicator of the presence of the influence of urban factors influencing water quality.
