Pix Piece
#06
August 2024

Pix Brook Water Quality: Phosphates

Sampling for Phosphates in the Pix Brook - where does it come from and why is it important?

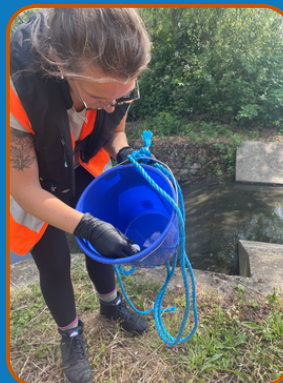
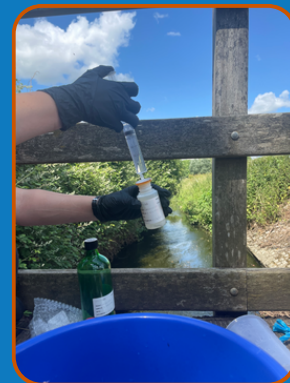
Figure 1 & 2. (Right) Water Quality Sampling in the Pix Brook

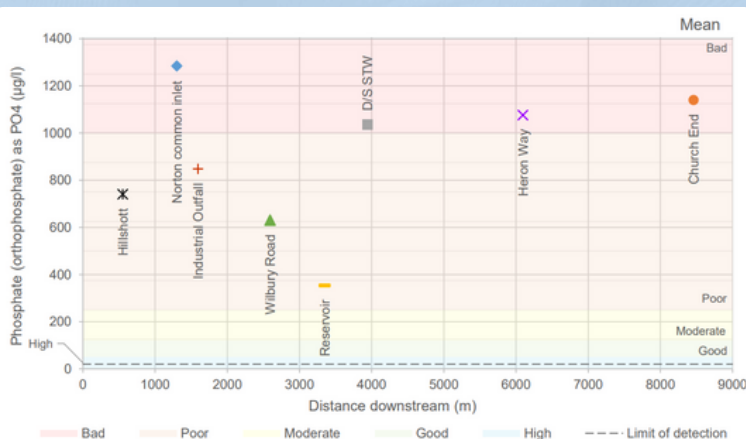
Figure 3. Phosphate levels (mean) across the Pix Brook compared against Water Framework Directive acceptable levels

ResilienTogether undertook water quality sampling for a nine month period at eight sites along the Pix Brook, shown in Figure 3 (Right). This provided a baseline water quality for a range of determinants. This Pix Piece focuses on the Phosphate Levels in the Pix Brook, what they mean and why Phosphate levels are important.

Phosphate concentrations vary along the Pix Brook. Four sites (Hillshott, Industrial Outfall, Wilbury Road and Reservoir) have an average that is classified as "poor", the remaining four sites have an average which are classified as "bad". The samples taken from the Norton Common inlet site had higher levels on average compared to the other sites. This indicates a potential source of contamination entering the Pix Brook between Hillshott and Norton Common. The concentration of phosphorous increases considerably downstream of the water recycling centre as phosphorous is likely to be entering the watercourse here in the effluent. Runoff from farmland around Stotfold and Arlesley could also be contributing to elevated levels in the Pix as many fertilisers used in farming contain phosphates.
