## Case study #07

## Covert 'turtle' gauging station

Camouflaged free-standing gauging stations to reduce the risk of vandalism and theft

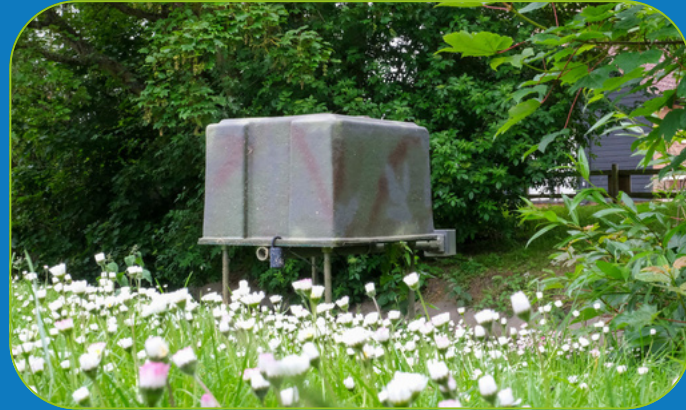
Figure 1. Covert 'turtle' gauge at Standalone Farm

Radio Data Networks Ltd (RDN) have installed a river level monitoring network across the Pix Brook. One gauge is located at Standalone Farm, upstream of a small weir. In this location the risk of damage to the asset from vandals and thieves is high due to its visibility and ease of access. This risk is further magnified as there is no structure (e.g. bridge) to mount and secure the gauge onto. Therefore, an innovative way to deter unwelcome attention and secure this valuable asset was required.

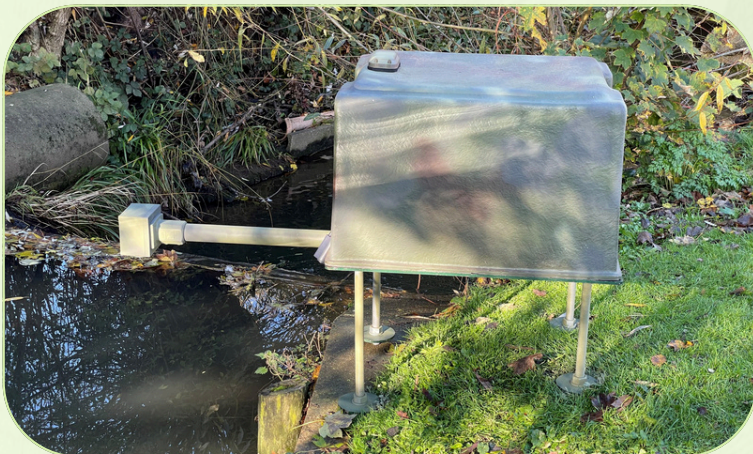
Figure 2. 'Turtle' gauge measuring Pix Brook water level

The solution is a free-standing structure that either stands on one bank with an outrigger holding the radar level sensor (Turtle) or a spanning structure across the river (Sedan Chair). The gauge and controls are located in a box that is painted to full NATO camouflage colours. As added protection against theft and weather conditions, the boxes are filled with 200kg of concrete and secured using padlocks. These gauge designs overcome the need for a structure to mount the gauge and allows for easy relocation (see Innovation Case Study #04).

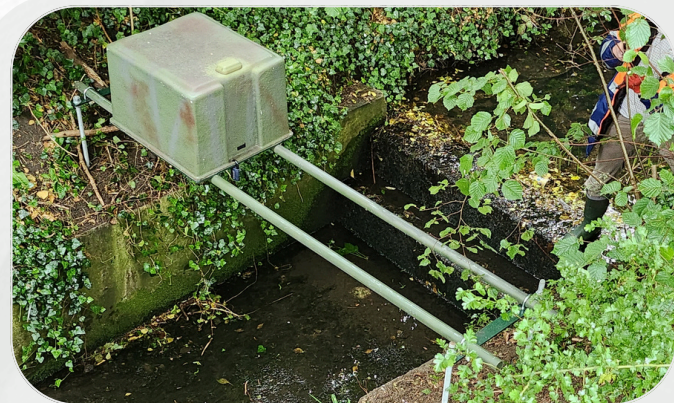
Figure 3. 'Sedan chair' water level gauge
