Pix Piece  
#02  
May 2024

## Pix Brook Water Quality: Ammonia

Sampling for ammonia in the Pix Brook, where does it come from and why is it important?

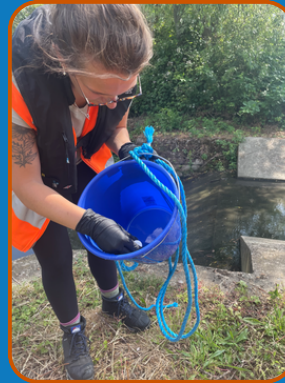
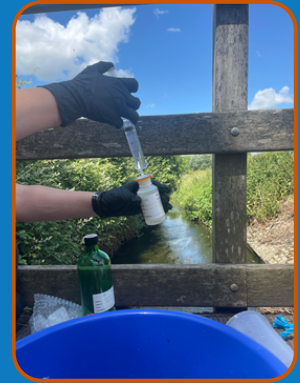
Figure 1 & 2. (Right) Water Quality Sampling in the Pix Brook

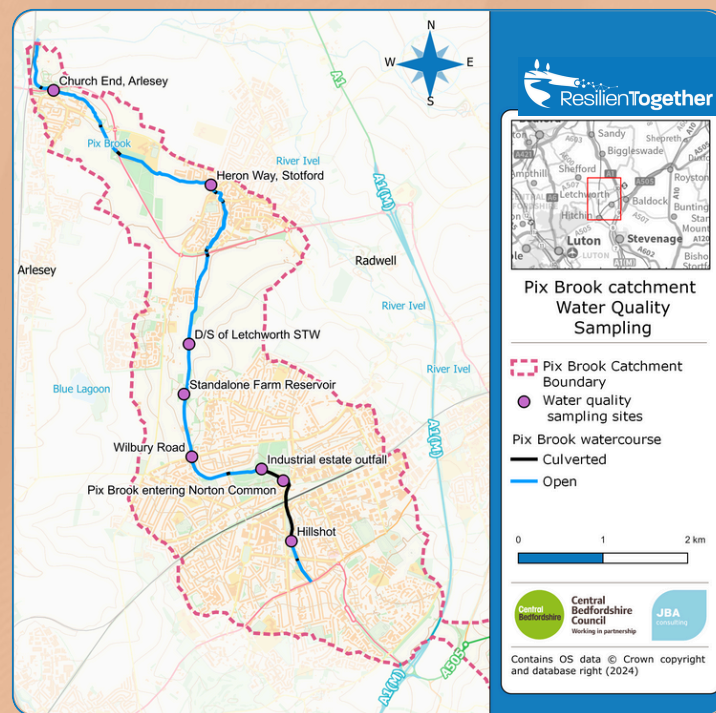
Figure 3. Map of Pix Brook water sampling locations

ResilienTogether undertook water quality sampling for a nine month period, at eight sites along the Pix Brook, shown in Figure 3 (Right). Pix Piece #01 provides information on how we undertook our water quality sampling. This provided a baseline water quality for a range of parameters across a long stretch of the watercourse which allowed us to build up a picture of where different parameters may be an issue and why. This Pix Piece focuses on the ammonia level in the Pix Brook, what they mean and why ammonia levels are important.

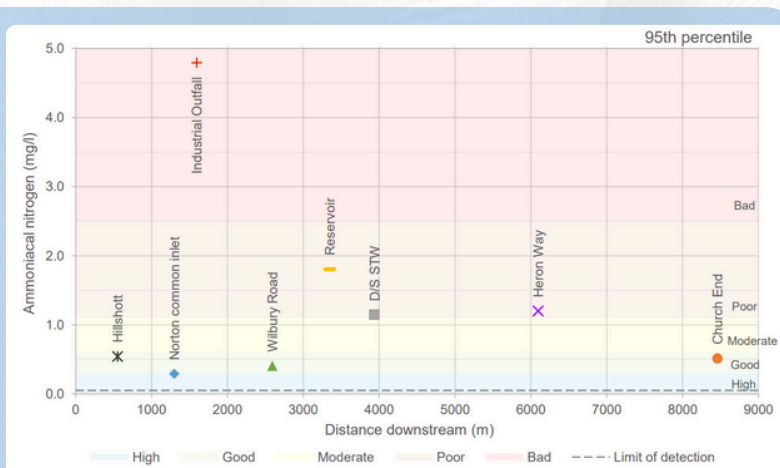
Figure 4. Ammoniacal nitrogen levels across the Pix Brook compared against Water Framework Directive acceptable levels

Figure 4 shows the amount of ammonia in the Pix Brook is broadly within the "high" and "good" classification in the upper Pix and at Church End. However, the Reservoir site, downstream (D/S) of the waste water treatment site and Heron Way site have a poor classification, as a result of elevated ammonia levels during the summer months. This may indicate either a source of ammonia entering the Pix between Wilbury Road and the Reservoir, or elevation of ammonia due to fish excretions within the Reservoir. The Industrial Outfall in Letchworth has ammonia levels that classify as "bad" and this could be because untreated wastewater and slurry runoff is entering the Pix at this point. Currently, this isn't increasing the concentration of ammonia in the Pix downstream.
