Case study #07

Covert 'turtle' gauging station

Camouflaged free-standing gauging stations to reduce the risk of vandalism and theft

ResilienTogether

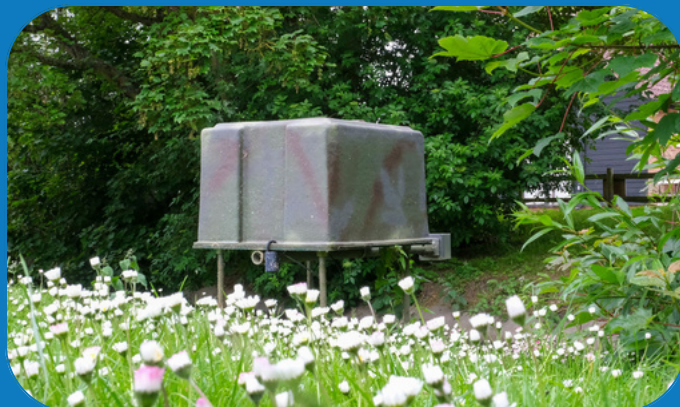
Figure 1. Covert 'turtle' gauge at Standalone Farm

The solution is a free-standing structure that either stands on one bank with an outrigger holding the radar level sensor (Turtle) or a spanning structure across the river (Sedan Chair). The gauge and controls are located in a box that is painted to full NATO camouflage colours. As added protection against theft and weather conditions, the boxes are filled with 200kg of concrete and secured using padlocks. These gauge designs overcome the need for a structure to mount the gauge and allows for easy relocation (see Innovation Case Study #04).

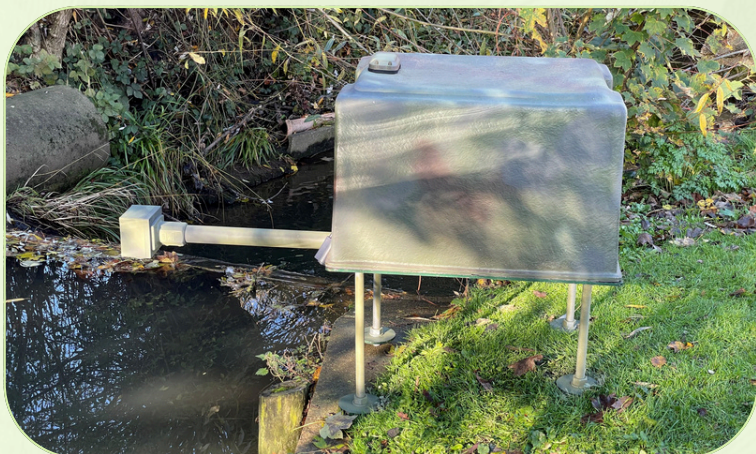
Figure 2. 'Turtle' gauge measuring Pix Brook water level

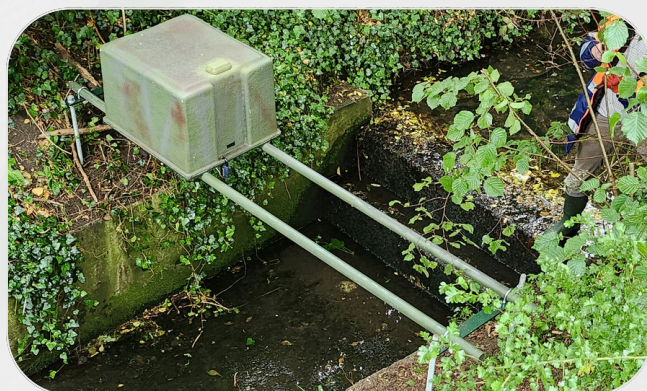
Figure 3. 'Sedan chair' water level gauge
